STM32F101x8/B, STM32F102x8/B and STM32F103x8/B medium-density device limitations

Silicon identification

This errata sheet applies to the revisions B, Z, Y, 1, 2 and X of the STMicroelectronics medium-density STM32F101xx access line and STM32F103xx performance line products, and to revision Y, 1, 2 and X of the STM32F102xx USB access line devices. These families feature an ARM™ 32-bit Cortex®-M3 core, for which an errata notice is also available (see [Section 1](#) for details).

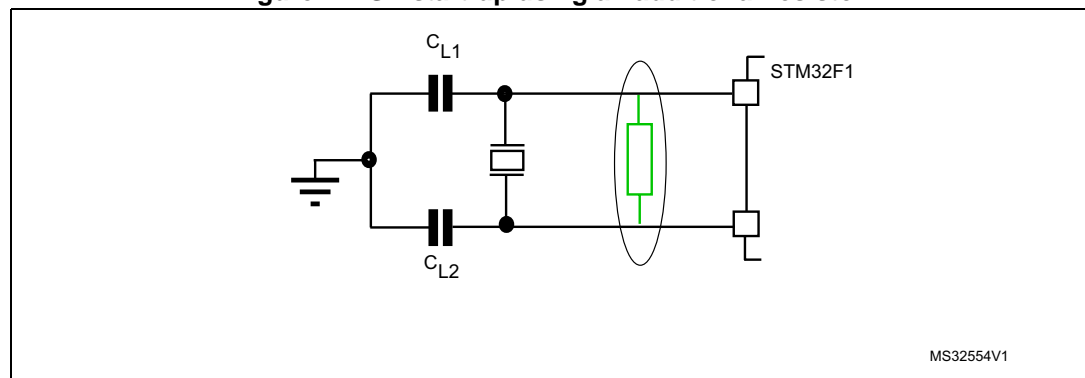
Figure 1. LSE start-up using an additional resistor

The LSE (Low Speed External) oscillator system has been designed to minimize the overall power consumption of the STM32F1 microcontroller. It is extremely important to take specific care in the design of the PCB to ensure this low power oscillator starts in harsh conditions. In some PCB designs without coating, an induced low leakage may prevent the LSE to start-up, regardless of the 32.768 KHz crystal used. This phenomenon is amplified in humid environments that create frost on the OSC32_IN/OSC32_OUT tracks. This unwanted behavior may happen only at the first back-up domain power-on of the device.

It is recommended to mount an additional parallel feedback resistor (from 16 M Ω to 22 M Ω) on board to help the oscillation start-up in all cases (see [Figure 1](#)). For more details on compatible crystals and hardware techniques on PCB, refer to AN2867 application note.
